### EXPERIENCES

### THE MODEL

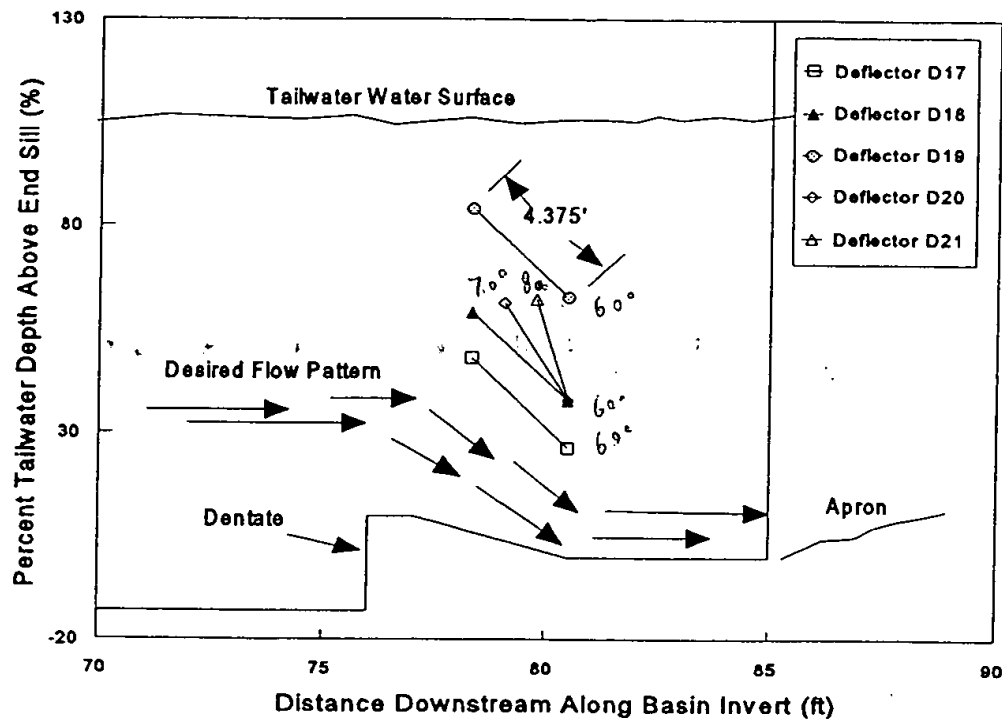
Figure 2. Deflector locations with respect to tailwater depth above the basin end sill.

*0.66 ft height*  
All of the deflectors tested were 4.375 ft deep and were located as shown in figure 2. Deflectors D17 through D19 were positioned at an angle of 60 degrees, and deflectors D20 and D21 were positioned at 70 and 80 degrees, respectively.
